FINAL COAT MODULE

TEST SUMMARY

Test Report
Measurement of Surface Current
On a Typical Automobile
Created by
Canadian Auto Preservation
Device

Report 746284-1

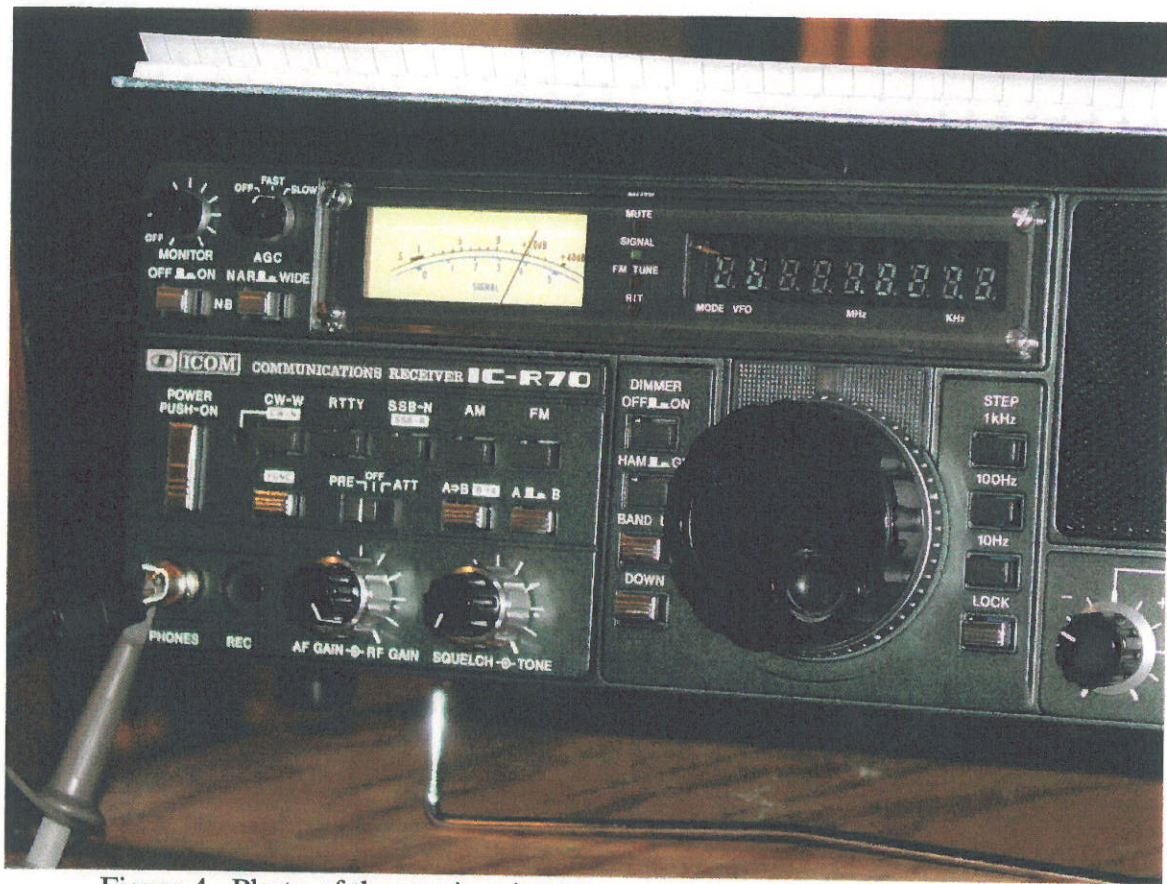
Next, we utilized a radio receiver with a calibrated loop current probe as the antenna, and this receiver was tuned to the strong signal frequency. The frequency used in this test was 1.8273 MHz. The radio receiver was a model IC-R70 Communications Receiver, manufactured by ICOM Incorporated of Osaka, Japan. The receiver was tuned to 1.8273 MHz on Lower Sideband, with the RF and audio gain knobs set to maximum sensitivity. A photograph of the receiver in use is shown in Figure 4. In this picture, the tuned frequency is just barely visible in the top number read-out. Also note the S-meter in the top left center of the radio display. The needle points to +20 dB, and this is a typical reading for several stronger current probe locations.

Figure 4, Photo of the receiver in use

In the lower left corner of Figure 4, the photo shows an oscilloscope probe attached to the phone jack of the receiver. When this was done, the oscilloscope would display a picture of the strong sinusoidal tone that we were listening to when the surface current was sensed. This display is shown on the oscilloscope in Figure 5.

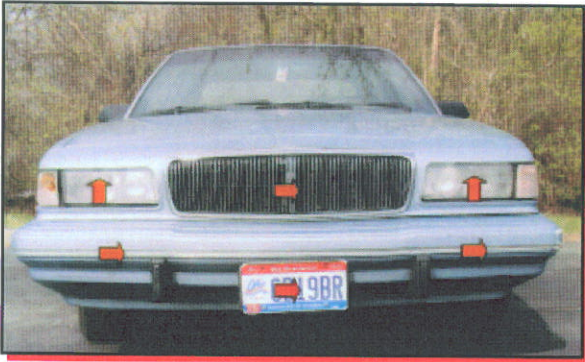
● *Front Currents*

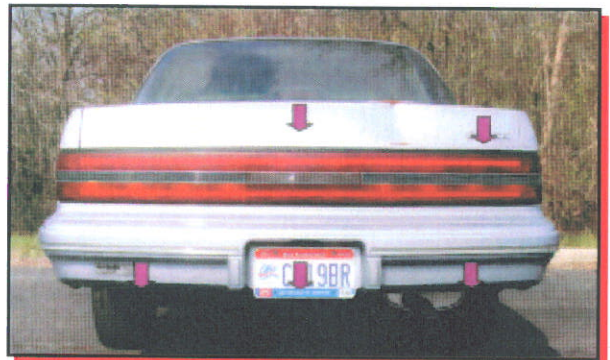
● *Rear Currents*
